COMPOSITE FAILURE ANALYSIS HANDBOOK  
VOL I - PROGRAM OVERVIEW

R.J. Kar  
Northrop Corporation  
One Northrop Avenue  
Hawthorne, California 90250-3277

February 1992

Final Report for Period January 1987 - October 1990

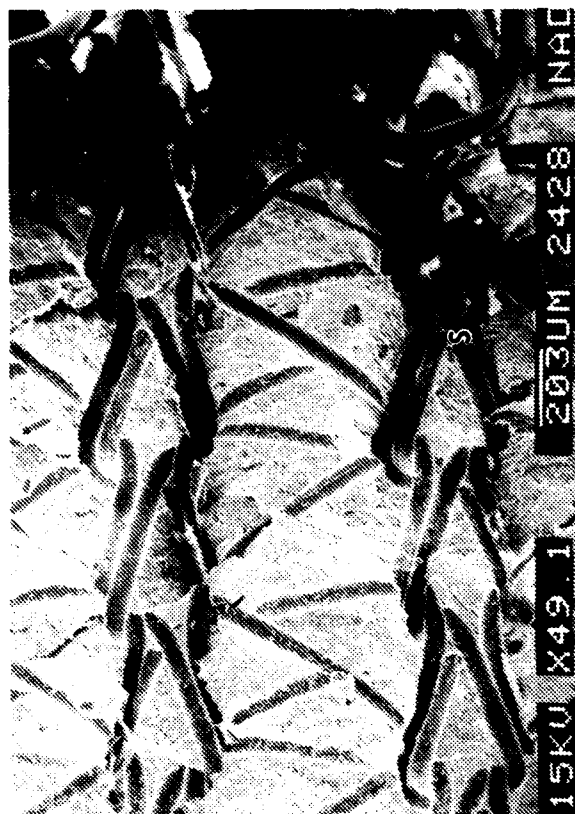
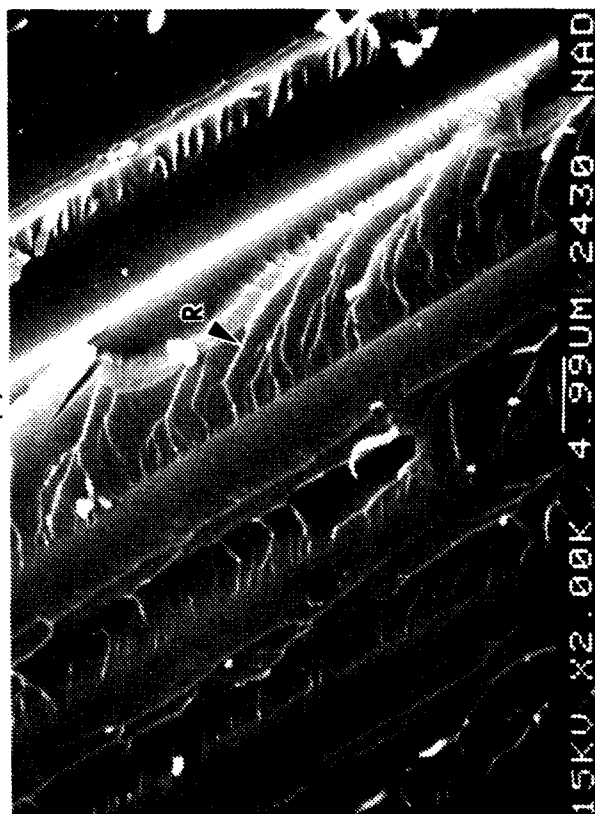
Figure 3-49. Optical and SEM Photographs of Failure in Unidirectional Gr/Ep Bonded to Quasi-Isotropic Gr/Ep With FM 300 Adhesive and Tested Under Mode I Tension

(a) Macro photograph  
(b) Rivers (R) in Adhesive Failure Region  
(c) Cohesive Failure Area

Figure 3-49 presents photographs of unidirectional Gr/Ep adhesively-bonded to quasi-isotropic Gr/Ep with FM-300 adhesive, and tested to failure in Mode I tension. The effect of varying ply orientation in one of the adherends resulted in a change in type of failure. Catastrophic fracture initiated in a mixed cohesive-adhesive manner with adhesive failure being the predominant failure mode (Figure 3-49a). The fracture direction could be mapped as before through mapping of the rivers in the fractured epoxy at the adhesive-adherend interface (Figure 3-49c).

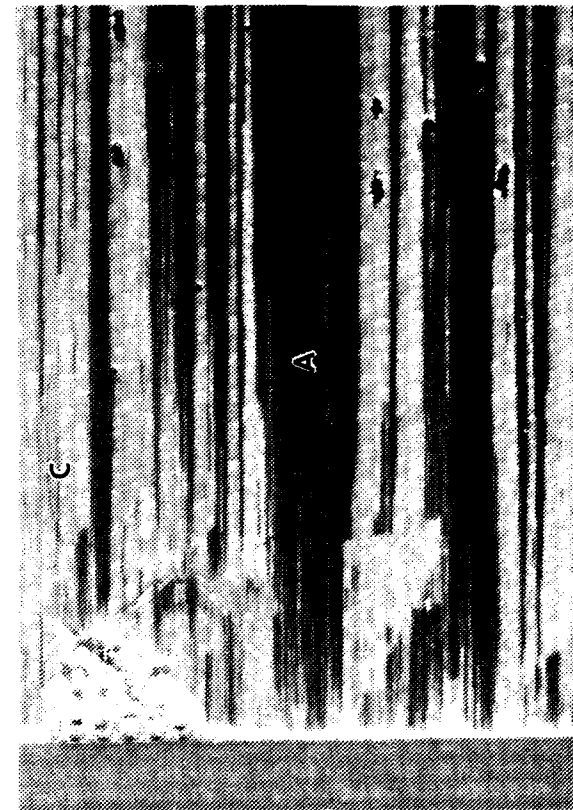
Figure 3-50. Optical and SEM Photographs of Fracture in Unidirectional AS4/3501-6 Gr/Ep Adherends Bonded With FM 300 Adhesive and Tested Under Mode I Tension and Mode II Interlaminar Shear  
(a) Macro photograph of Fracture  
(b), (c) Low Magnification (4X) Photographs Showing Cohesive (C) and Adhesive (A) Failure Characteristics

Figure 3-50 illustrates failure characteristics in unidirectional Gr/Ep adherends bonded with FM-300 adhesive, and tested under mixed loads (Mode I tension plus Mode II interlaminar shear). Application of peel resulted in a mixed cohesive-adhesive failure with no clear transition from one failure mode to the other. SEM examination of the fractured adhesive in the cohesive areas revealed no features indicative of crack-propagation direction. The fractured adherend in the adhesive failure areas exhibited peel characteristics (hackles plus river patterns).

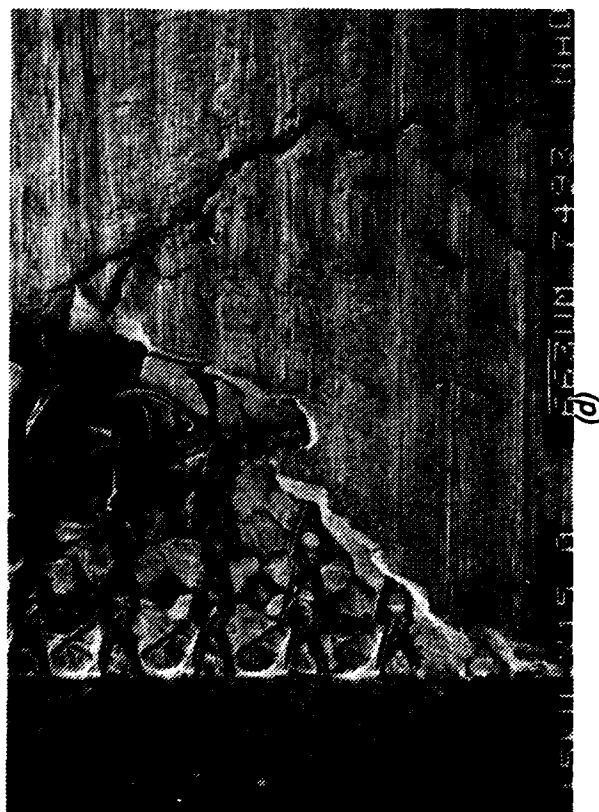
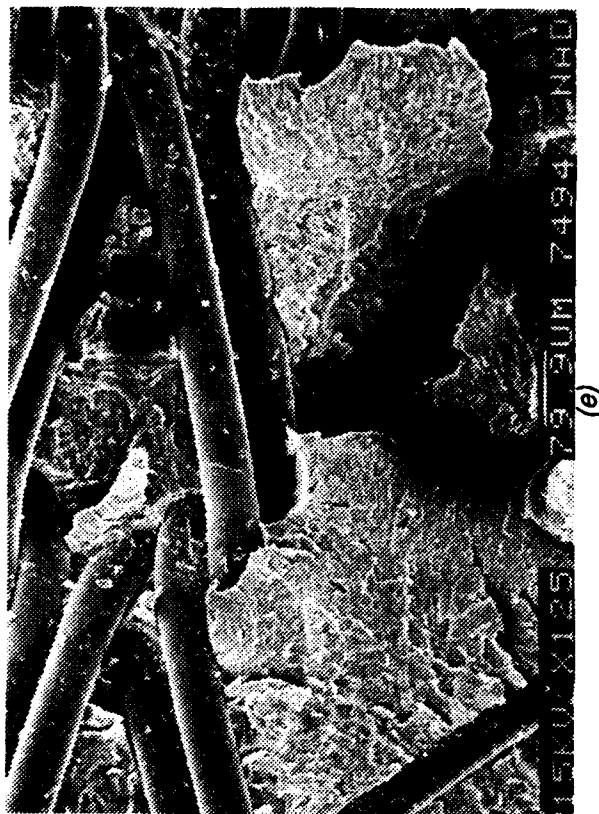
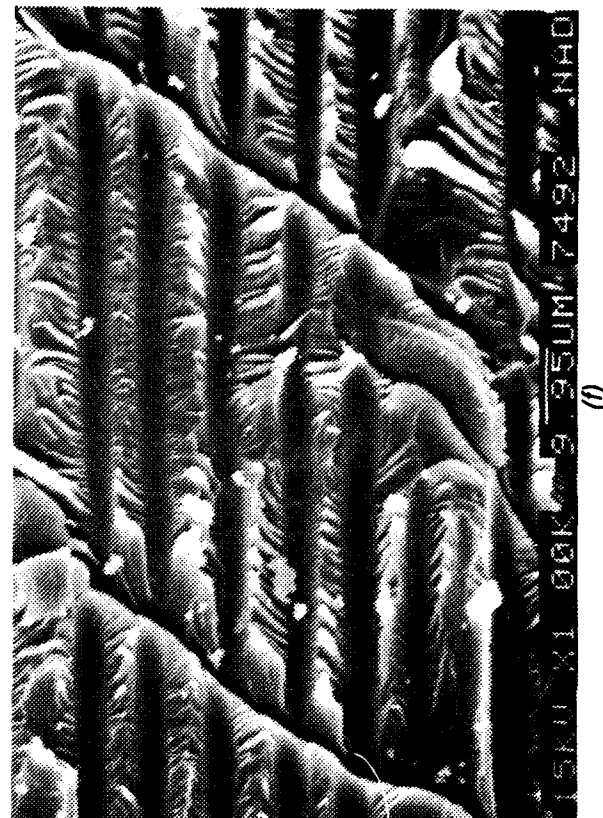
Figure 3-50. (Continued)  
 (d), (e) Cohesive Failure in FM 300 Adhesive  
 (f) Peel Characteristics in Fractured Adherends  
 CD = Crack-propagation direction

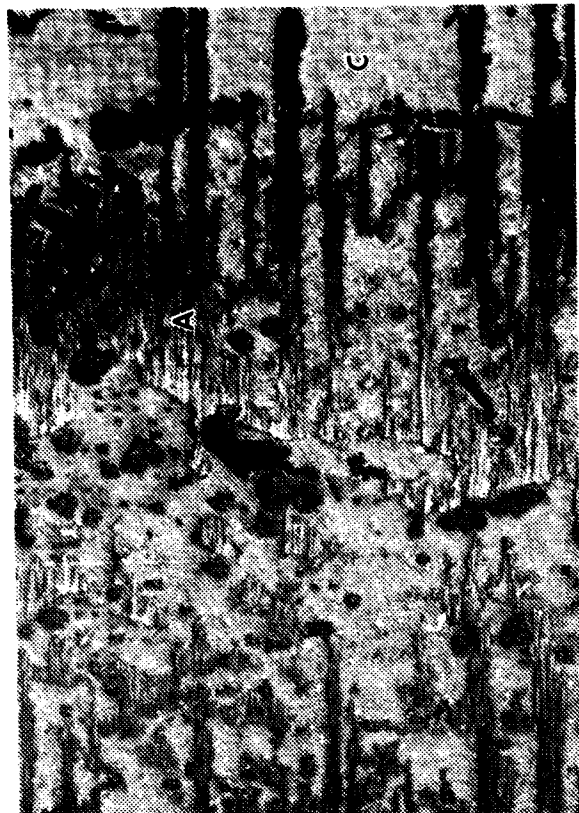
Figure 3-51. Optical Photographs of Failure in Unidirectional AS4/5250-3 Gr/BMI Adherends Bonded With EA 9673 Adhesive and Tested Under Interlaminar Mode I Tension

(b), (c) Low Magnification (4X) Photographs Showing Details in Cohesive and Adhesive Failure Regions

A = Adhesive failure  
C = Cohesive failure  
CD = Crack-propagation direction  
M = Mixed cohesive-adhesive failure

Figure 3-51 and 3-52 illustrate failure characteristics in unidirectional Gr/BMI adherends bonded with EA 9673 adhesive, and tested under interlaminar Mode I tension in a manner similar to the Gr/Ep coupons. On a macroscopic scale failure initiated in a mixed cohesive-adhesive mode (Figures 3-51a and 3-51b). With increasing crack length, there was a transition to a cohesive failure mode, and eventually to an adhesive failure mode. The fracture direction could be established as in the Gr/Ep specimens through mapping of the rivers in the adhesive or cohesive failure areas (Figure 3-52).

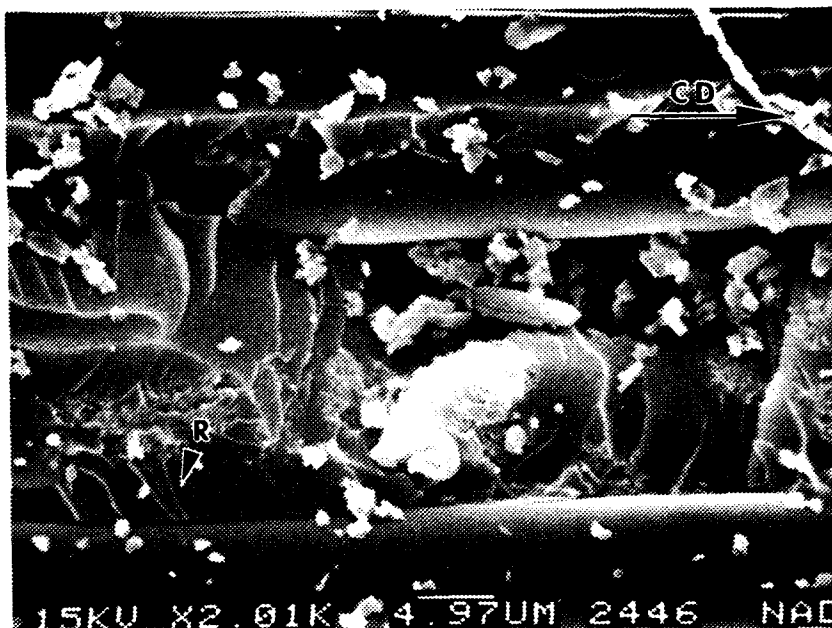
**Figure 3-52. SEM Photograph of Failure in Unidirectional AS4/5250-3 Gr/BMI Adherends Bonded With EA 9673 Adhesive and Tested Under Interlaminar Mode I Tension Showing Rivers (R) in Adhesive Failure Region**  
 CD = Crack-propagation direction

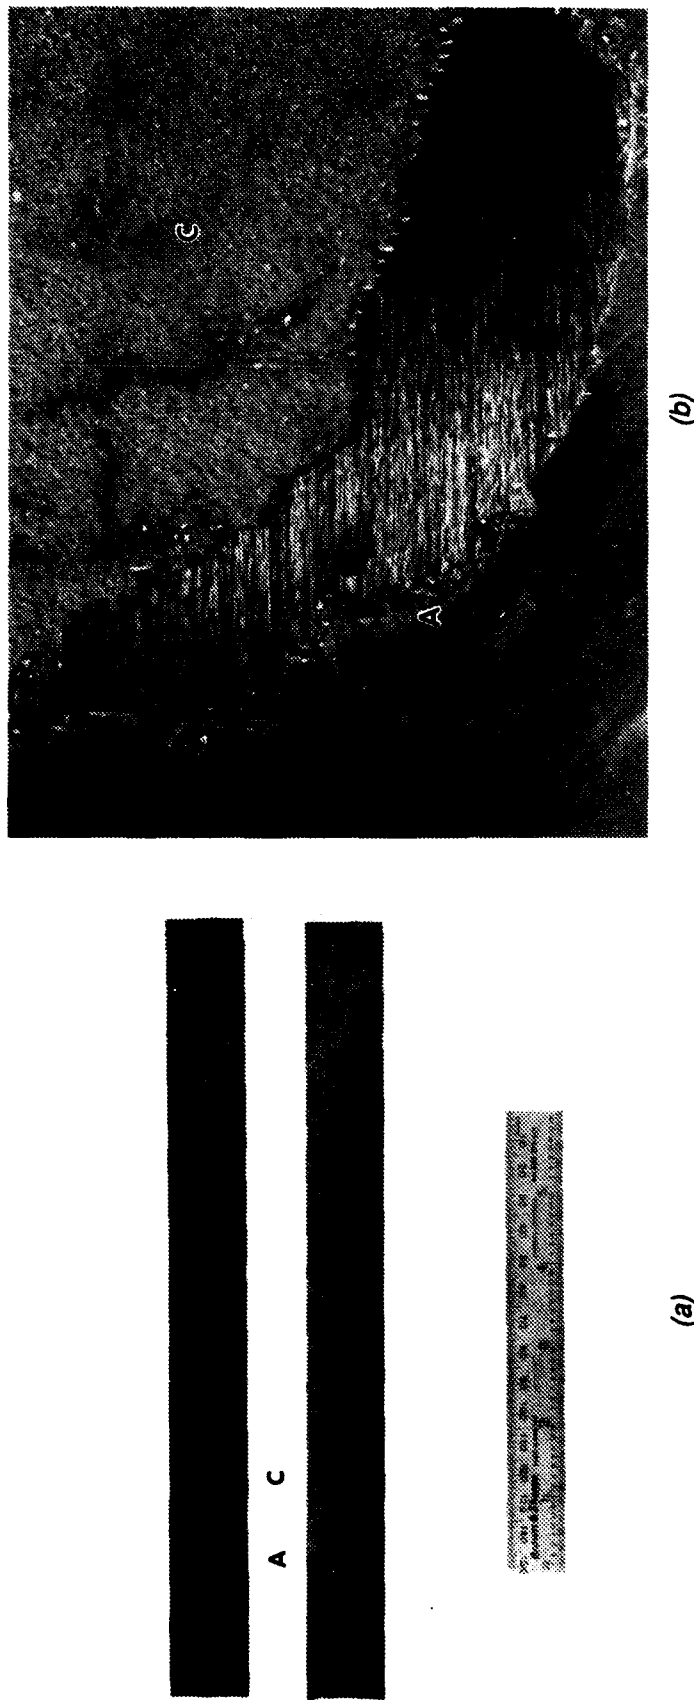
Figure 3-53. Optical and SEM Photographs of Failure in Unidirectional Gr/BMI Bonded to Quasi-Isotropic Gr/BMI With EA 9673 Adhesive and Tested Under Mode I Tension  
 (a) Macro photograph  
 (b) Low Magnification (4X) Photograph Showing Transition From Adhesive to Cohesive Failure

A = Adhesive failure  
 C = Cohesive failure  
 CD = Crack-propagation direction

Figure 3-53 shows photographs of unidirectional Gr/BMI adhesively-bonded to quasi-isotropic Gr/BMI with EA 9673 adhesive and tested to failure in Mode I tension. Fracture initiated due to adhesive failure. With increasing crack-length, there was a transition to cohesive failure

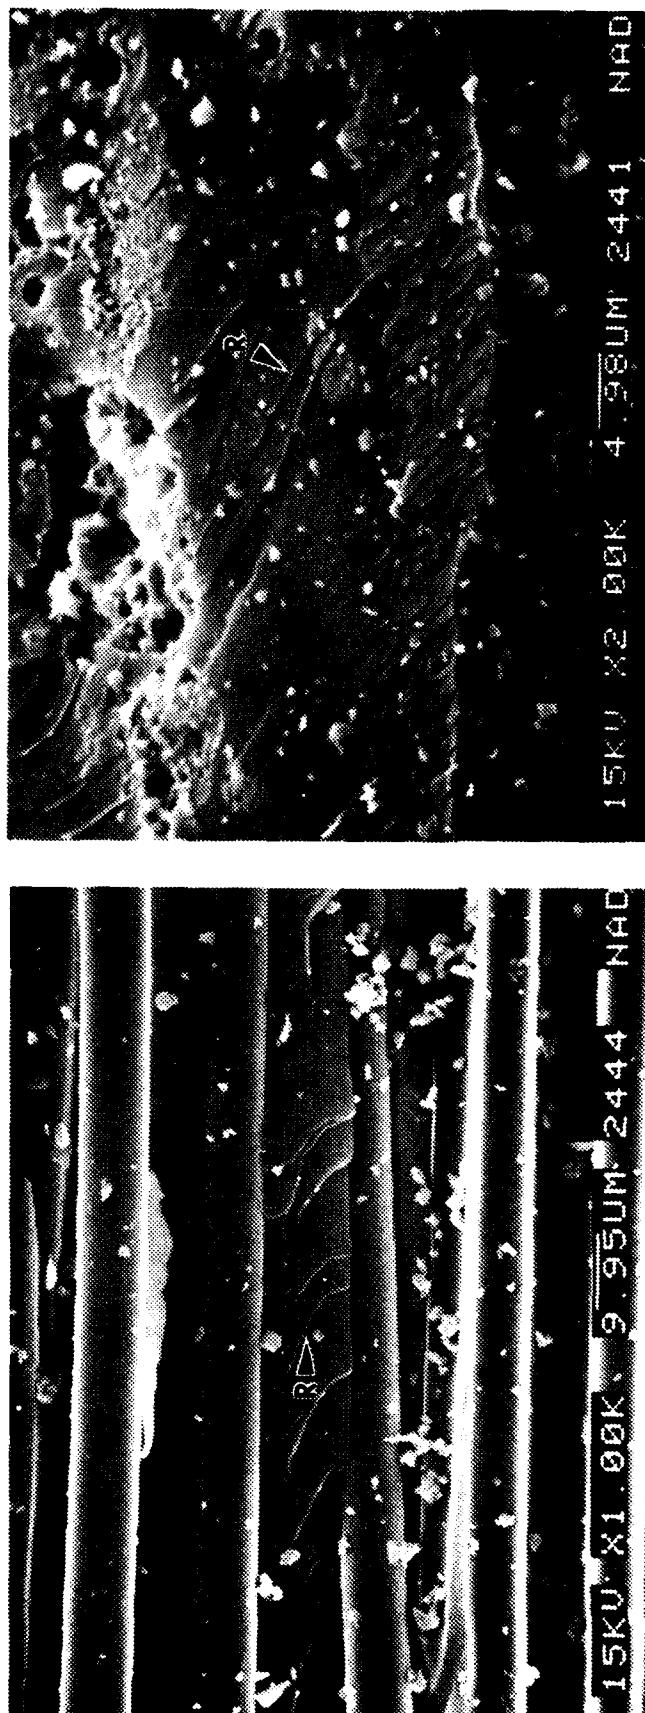
Figure 3-53. (Continued)  
 (c) Rivers (R) in Adhesive Failure Area  
 (d) Rivers (R) in Cohesive Failure Area  
 CD = Crack-propagation direction

of the adhesive. The fracture direction could be mapped as before through mapping of the rivers oriented along the direction of crack-propagation (Figures 3-53c and 3-53d).

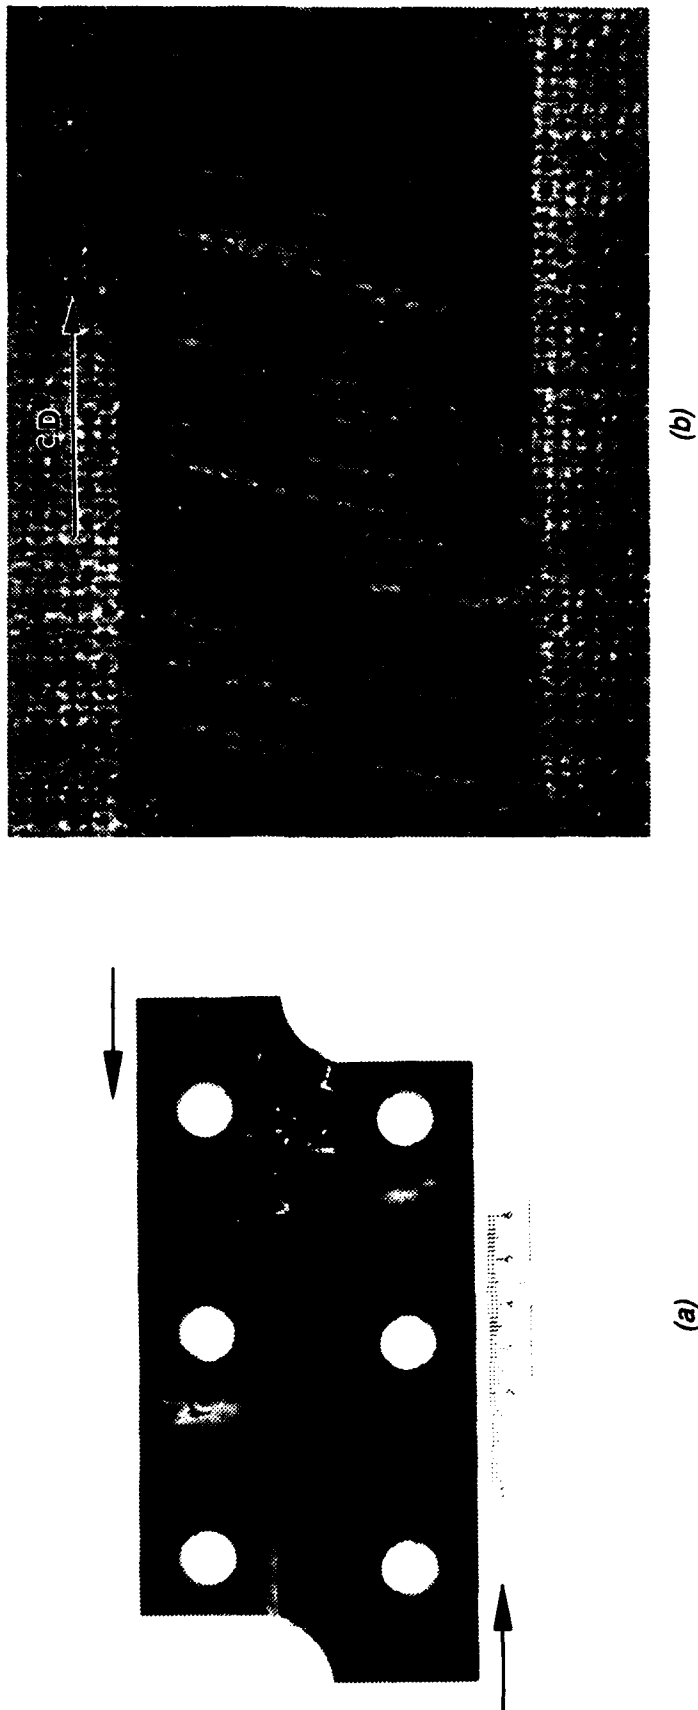
Figure 3-57. Optical and SEM Photographs of AS4/3501-6 Gr/Ep - [0/90]<sub>6s</sub>, In-Plane Shear-Tested (Baseline)

(a) Macro photograph of Rail Shear Specimen

(b) Close-Up View of In-Plane Shear Region

CD = Crack-propagation direction

Figures 3-57a and 3-57b present macrophotographs of a failed [90/0]<sub>6</sub> Gr/Ep rail-shear specimen. Testing had resulted in in-plane shear failure in the central regions of the specimen. The 90-degree plies had been subjected to rotational bending loads, and this resulted in longitudinal splitting of the fibers, as illustrated in Figure 3-57b.

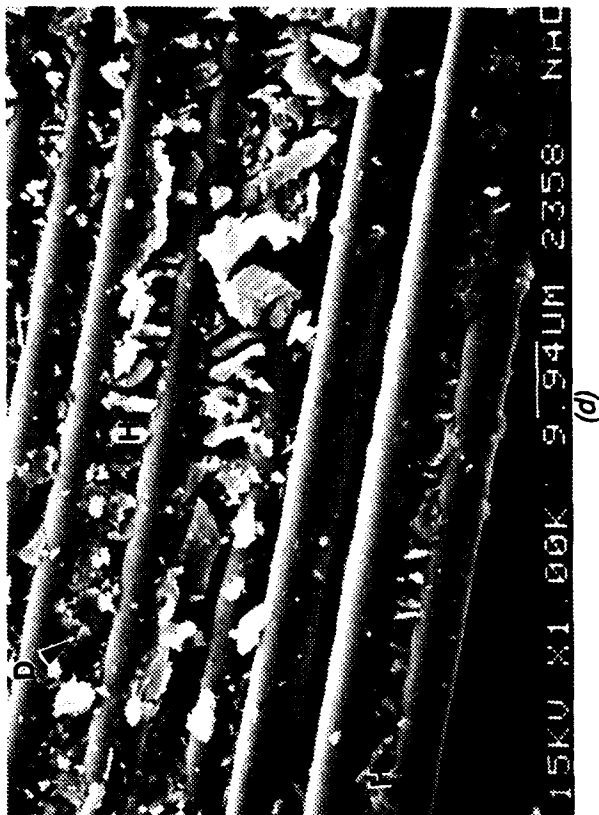
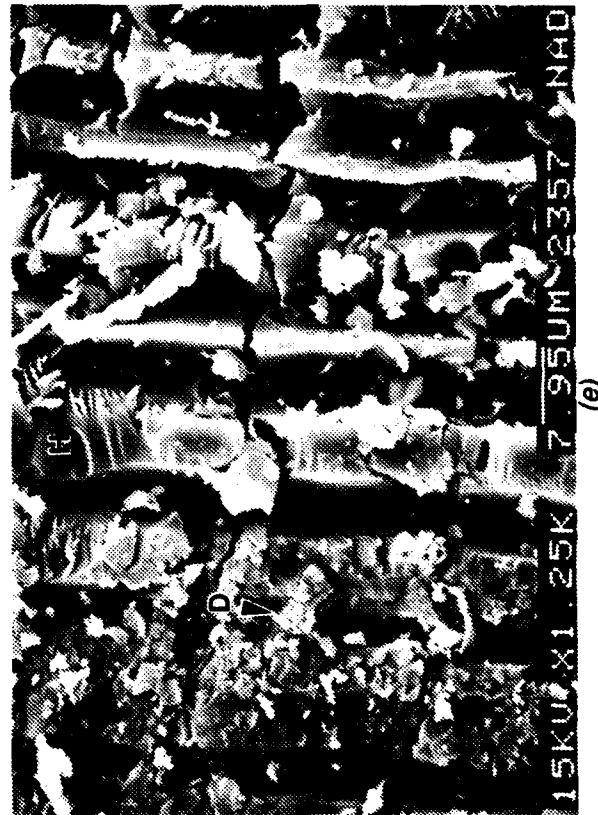
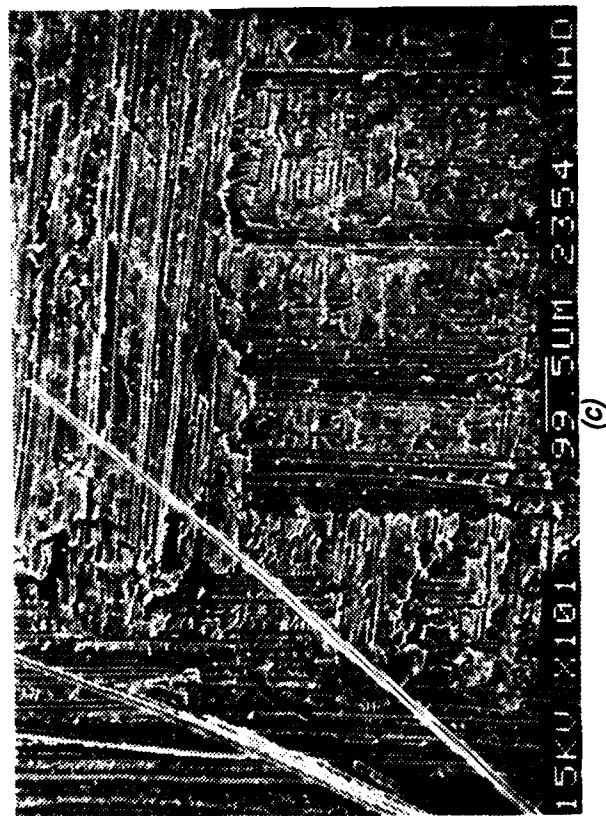
Figure 3-57. (Continued)  
 (c) Delaminated Fracture Surface of Region  
 Exposed by Sectioning Outer Plies  
 (d), (e) Fracture in 90 and 0 Degree Plies

CD = Crack-propagation direction  
 D = Compression debris  
 H = Hackles

Figures 3-57c, 3-57d and 3-57e show SEM photographs of typical fracture characteristics. Testing had also resulted in delaminations between the 90 and 0 degree plies. Figure 3-57c shows a typical delaminated region (exposed by sectioning the outer plies). The fracture characteristics in the 90 and 0 degree plies were typical of shear, namely occurrence of hackles (Figures 3-57d and 3-57e). In addition resin debris were also observed indicating compression characteristics (Figure 3-57d). These observations suggest that the failure consisted of fiber splits, delamination due to shear, and compression of the fiber bundles.

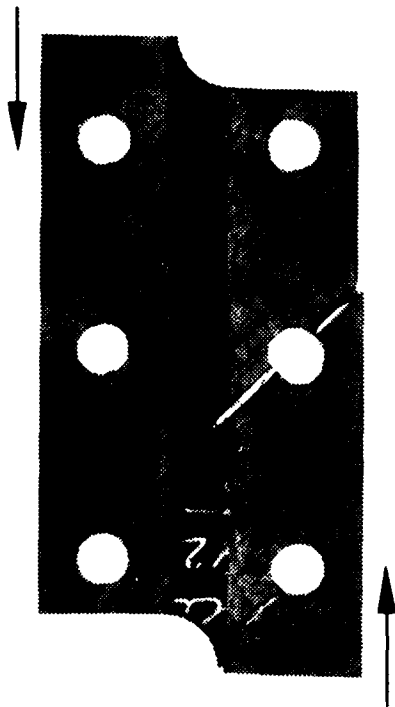
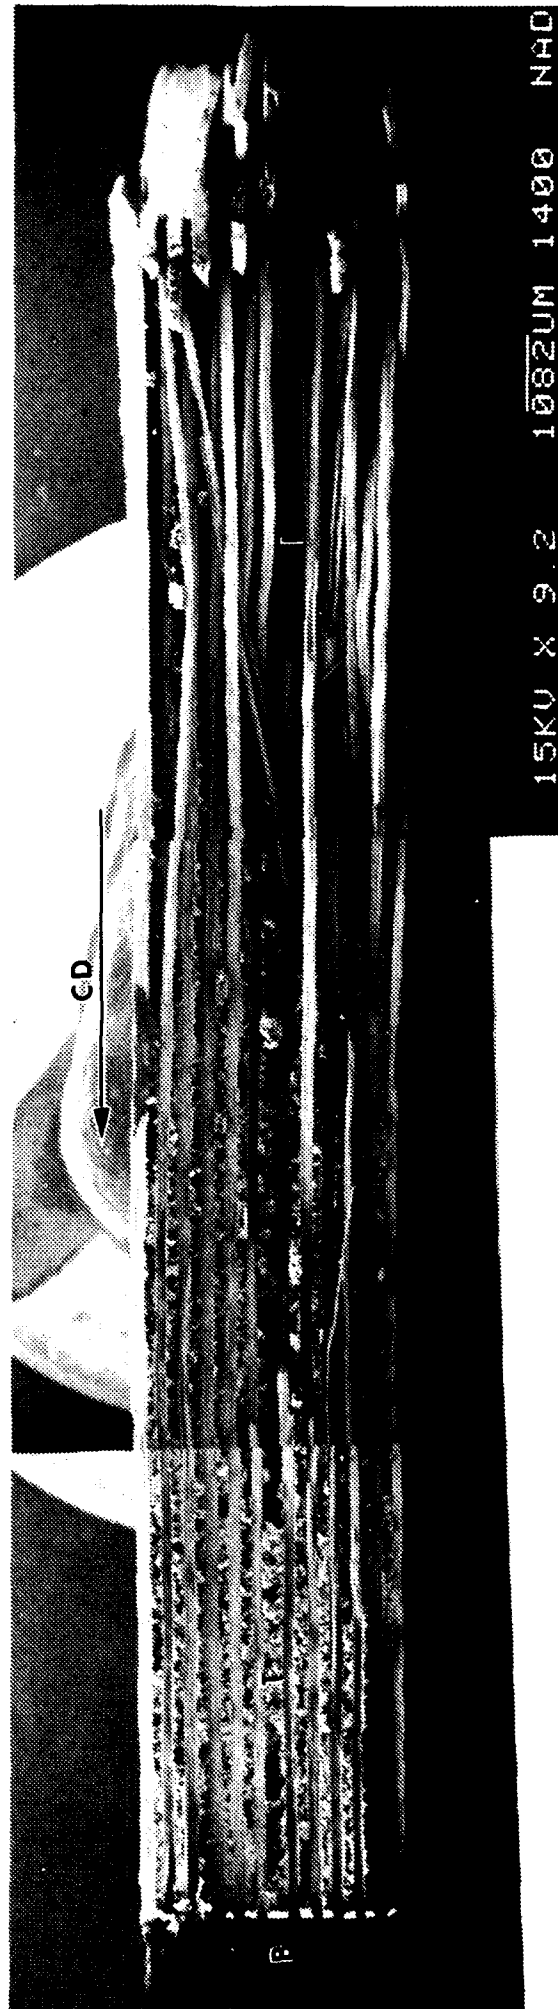
Figure 3-58. Optical and SEM Photographs of AS4/3501-6 Gr/Ep - [+45/-45]<sub>gs</sub> , In-Plane Shear Tested (Baseline)

(b) Close-up View of Fracture Viewed End-On

CD = Crack-propagation direction

I = In-plane shear region

T = Secondary transverse tensile fracture

Figure 3-58a presents a macrophotograph of a failed [+45/-45]<sub>6</sub> Gr/Ep rail-shear specimen. Testing had resulted in catastrophic fracture of the coupon. Figure 3-58b is a collage illustrating the through thickness fracture viewed end-on. The in-plane shear fracture regions could easily be distinguished from the secondary transverse tensile fracture that initiated at the bolt-hole. The in-plane shear fracture regions had a relatively smoother topography than the transverse tensile fracture regions, as shown in Figure 3-58b. The coarse chevrons indicate that the secondary fracture initiated at the bolt hole.

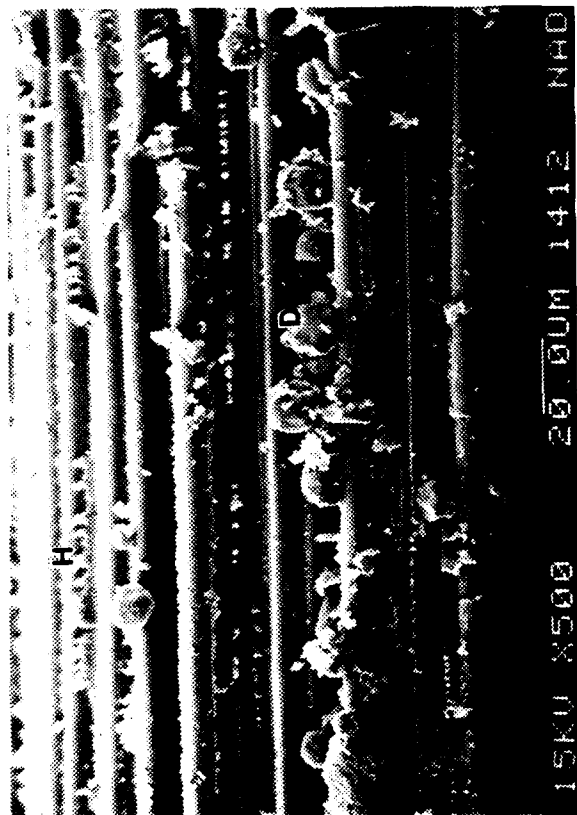
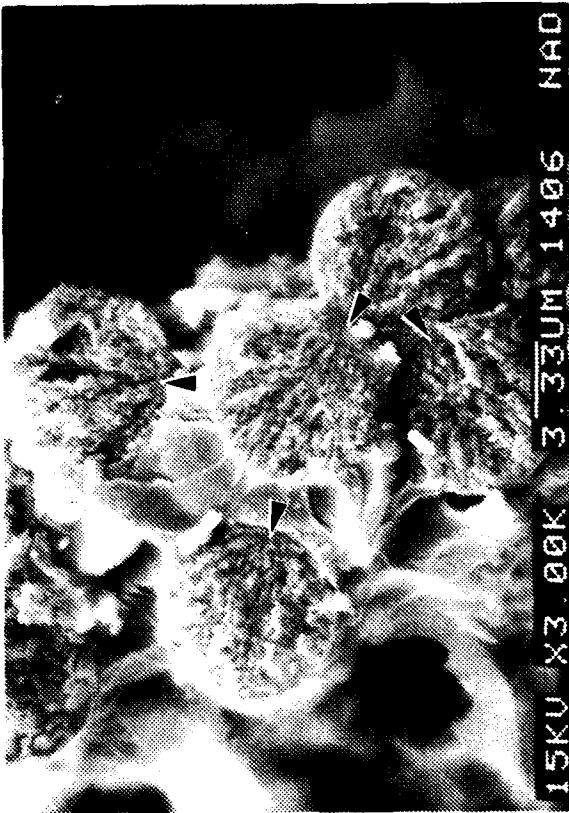
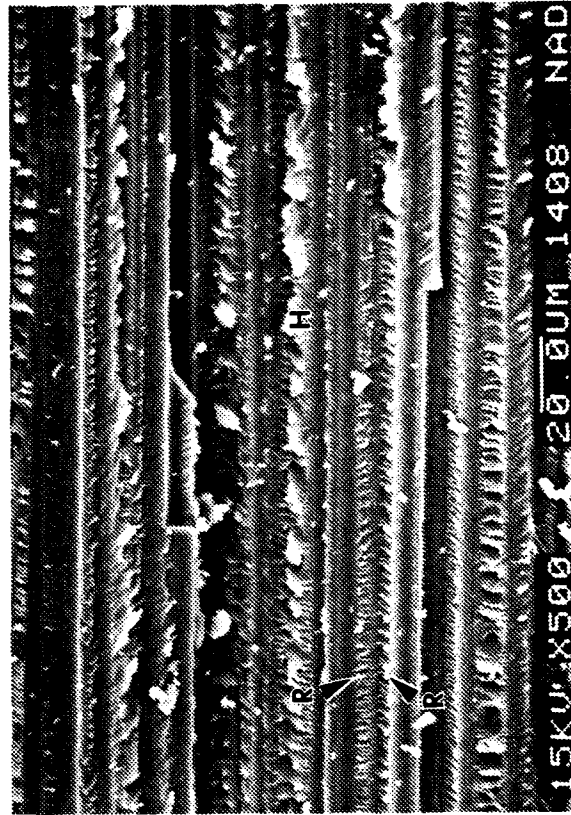
Figure 3-58. (Continued)  
 (c) Fracture in +45 Degree Ply Showing Hackles (H) and Compression Debris (D)  
 (d) Fracture in -45 Degree Ply Showing Tensile Fiber Breaks  
 Note DAF radials (arrows)  
 (e) Transverse Tensile Fracture in Secondary Failure Region Showing Rivers (R) and Hackles (H)  
 Note rivers oriented away from bolt-hole

CD = Crack propagation direction  
 D = Compression debris  
 H = Hackles  
 R = Rivers

Figures 3-58c through 3-58e illustrate microscopic fracture features in these regions. The +45-degree plies (oriented parallel to the applied shear loads) exhibited hackles and compression debris (Figure 3-58c) in the in-plane shear fracture region. The -45-degree plies (oriented normal to the applied shear loads) exhibited transverse tensile fracture characteristics, with individual fibers exhibiting DAF radials, oriented toward the direction of macroscopic fracture (Figure 3-58d).

Figure 3-58e shows the transverse tensile fracture characteristics observed in regions close to the bolt-hole. The fractured epoxy on the +45-degree plies was decorated with rivers and hackles, with the rivers oriented away from the bolt-hole, indicating that secondary failure had initiated at the bolt-hole.

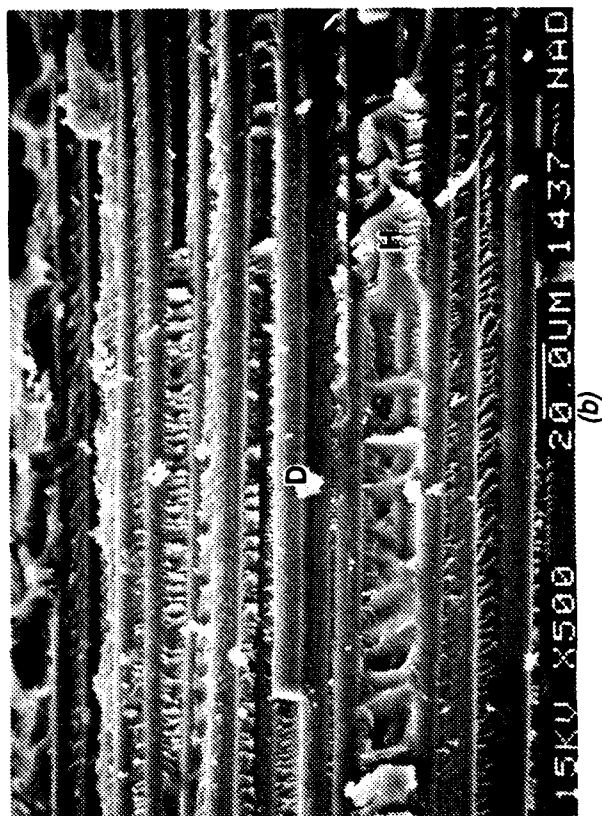
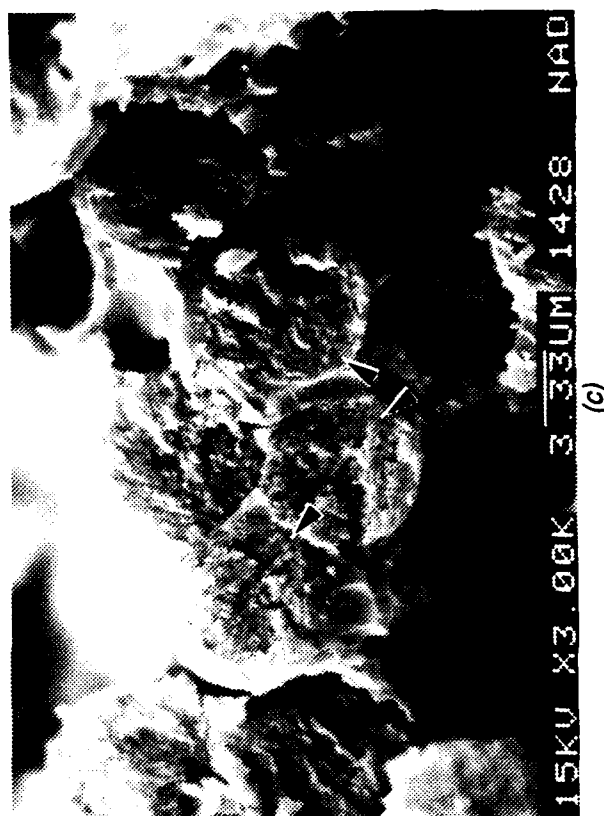
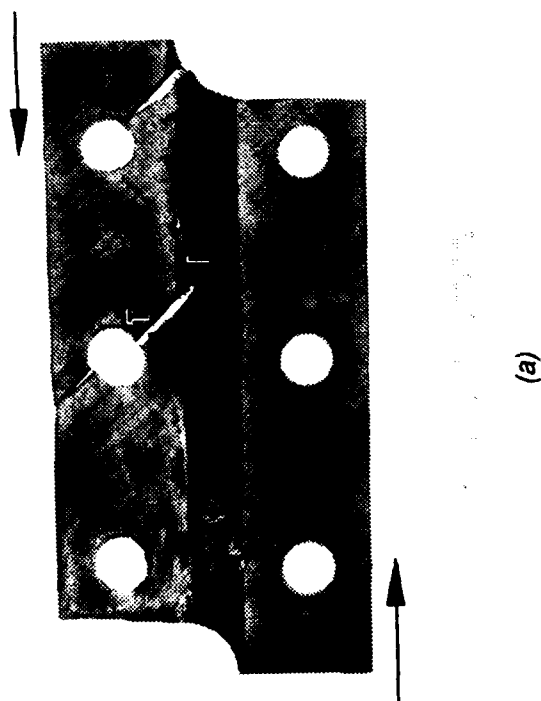
Figure 3-59. Optical and SEM Photographs of AS4/3501-6

Uncured Gr/Ep - [+45/-45]<sub>6s</sub>, In-Plane Shear Tested

(b) Fracture in +45 Degree Ply Showing Hackles (H)

(c) Fracture in -45 Degree Ply Showing Tensile Fiber

CD = Crack-propagation direction

I = In-plane shear region

T = Secondary transverse tensile fracture

Figure 3-59 shows macroscopic and microscopic fracture features in AS4/3501-6 Gr/Ep - [+45/-45]<sub>6S</sub>, that was undercured (for undercure process details refer to Reference 5). The fracture characteristics were extremely similar to that of baseline Gr/Ep, described above. The in-plane shear fracture regions were characterized by either hackles (Figure 3-59b) or tensile fiber breaks (Figure 3-59c). Secondary fracture occurred, similar to the baseline, at the bolt holes.

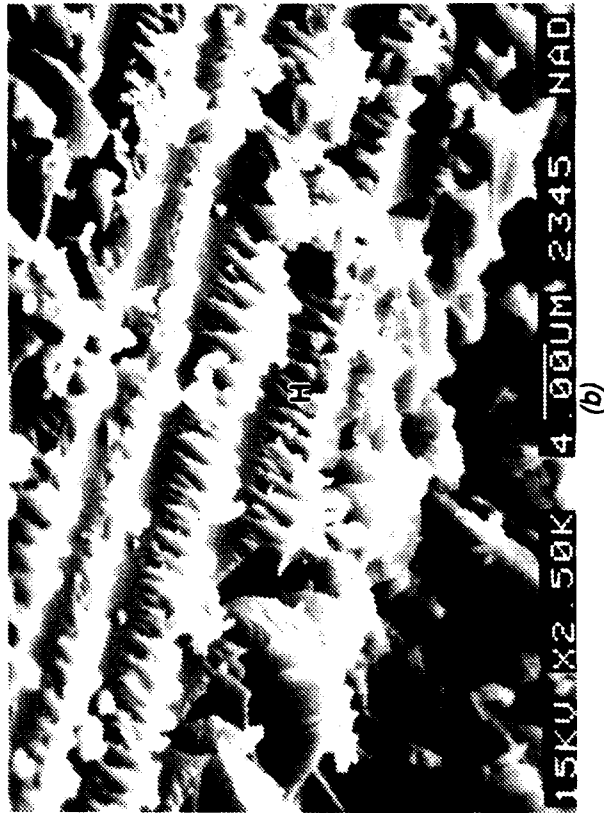
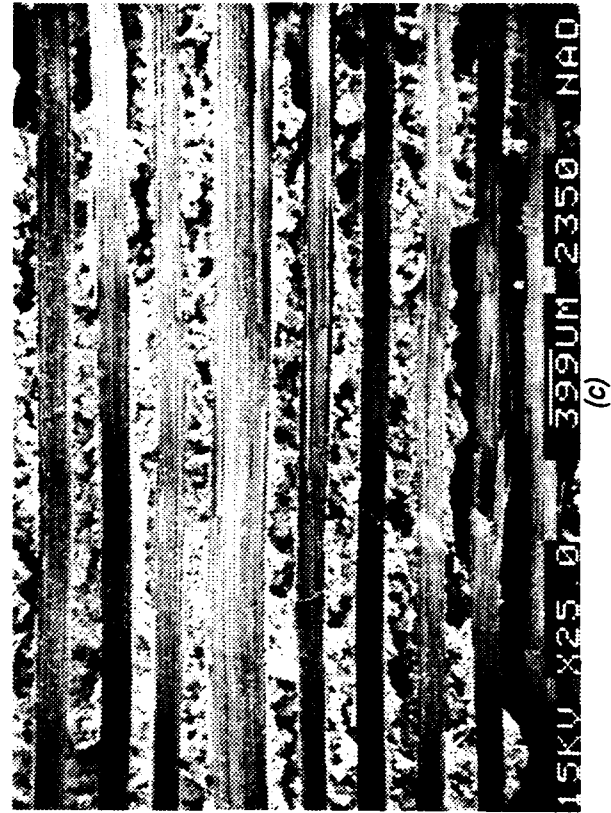
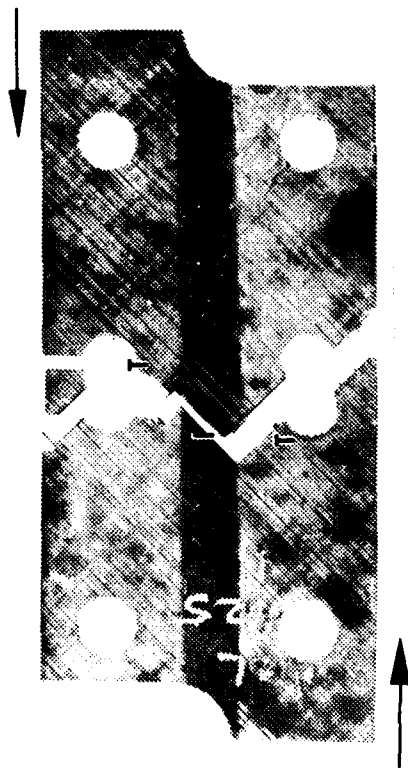
(b) Fracture in +45 Degree Ply Showing Hackles (H)

(c) Transverse Tensile Fracture in Secondary Failure Region

CD = Crack-propagation direction

I = In-plane shear region

T = Secondary transverse tensile fracture

Figure 3-60 shows macroscopic and microscopic fracture features in AS4/3501-6 Gr/Ep - [+45/-45]<sub>6S</sub>, that was overcured (overcure process details are given in Reference 5). On a macroscopic scale, overcuring appeared to have resulted in more severe catastrophic fracture in the rail-shear specimen, than for the baseline. On a microscopic scale, the fracture characteristics were similar, as is illustrated in Figures 3-60b and 3-60c.

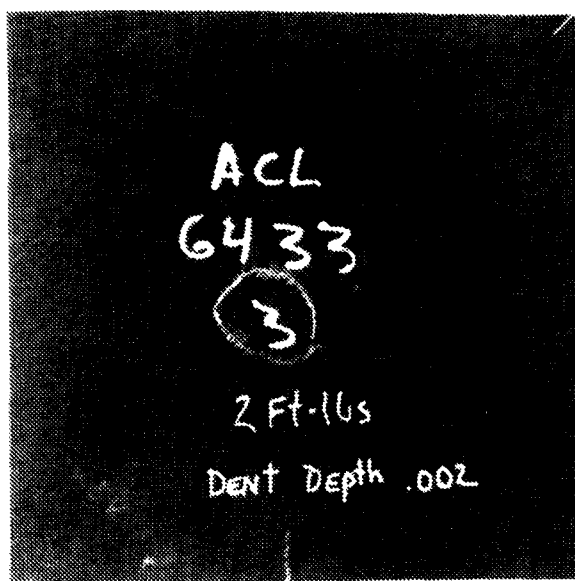
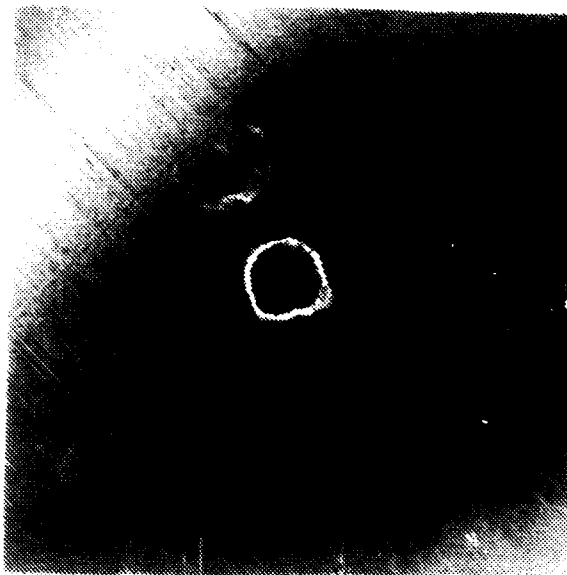
ACL 6433-3 16 PLY (GR/EP)  
IMPACT 2 FT LBS.

**Figure 3-61. Photographs of 16-Ply AS4/3501-6 Gr/Ep Impacted With a Force of 2 ft-lbs to Achieve Matrix Cracking/Delamination**  
**(a) As-Tested Specimen**  
**(b) A-Scan of Impact Damage**  
**(c) Mating Fracture Halves Showing Impact Signature (Arrows)**

Figures 3-61 through 3-63 show photographs of impact tested Gr/Ep in which the three principal failure conditions were developed. The damage zones for each of the three failure modes were mapped using A-scan techniques. In all cases, impact was characterized by a characteristic fracture signature, namely a zone of macroscopic delaminations. The plane of maximum delamination in each case was exposed using ply-removal techniques previously developed in Task 2.

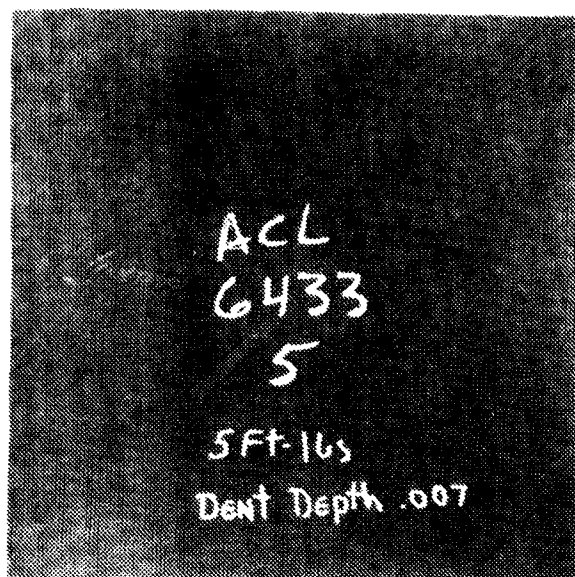
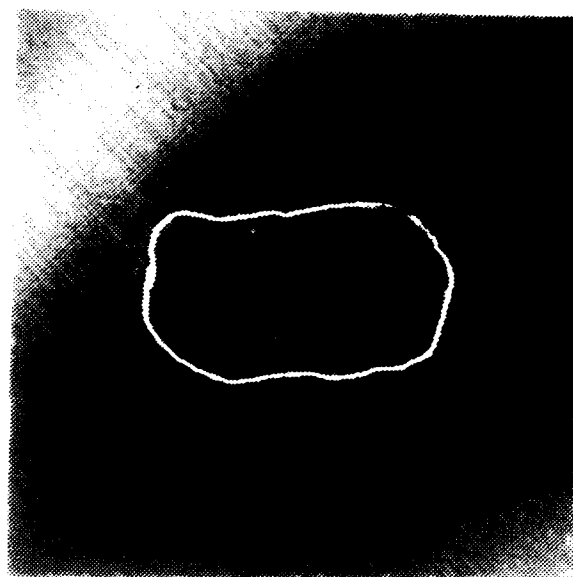
ACL 6433-5 16 PLY (GR/EP)  
IMPACT 5 FT-LBS

**Figure 3-62. Photographs of 16-Ply AS4/3501-6 Gr/Ep Impacted With a Force of 5 ft-lbs to Achieve Composite Buckling**  
**(a) As-Tested Specimen**  
**(b) A-Scan of Impact Damage**  
**(c) Mating Fracture Halves Showing Impact Signature (Arrows)**

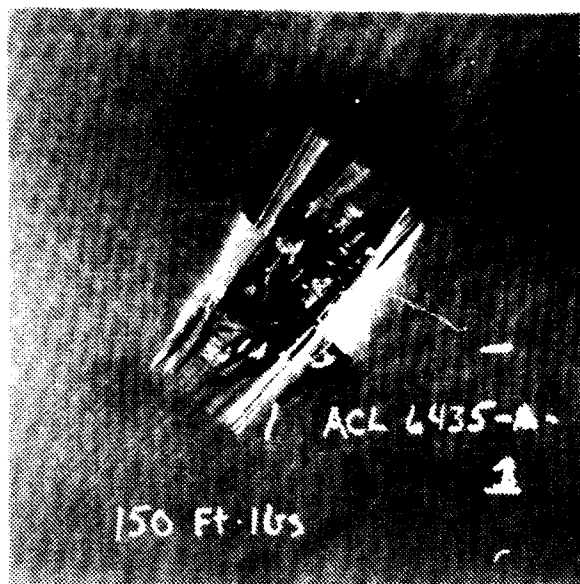
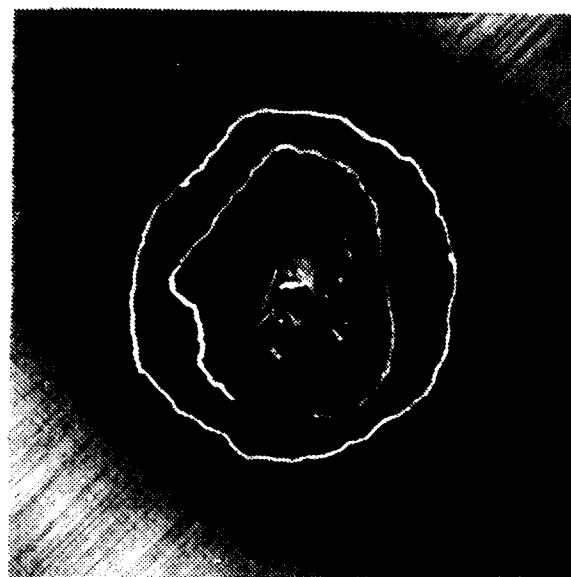
ACL 6435 148 PLY (GR/EP)  
IMPACT - 150 FT LBS

**Figure 3-63. Photographs of 48-Ply AS4/3501-6 Gr/Ep Impacted With a Force of 150 ft-lbs to Achieve Through-Hole Damage**  
**(a) As-Tested Specimen**  
**(b) A-Scan of Impact Damage**  
**(c) Mating Fracture Halves Showing Impact Signature (Arrows)**

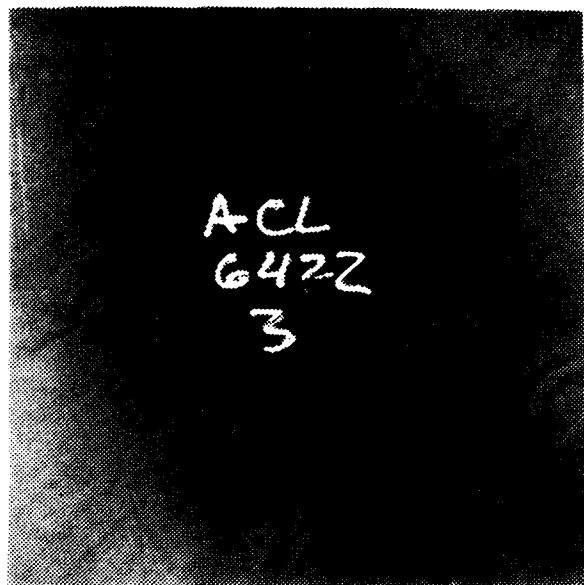
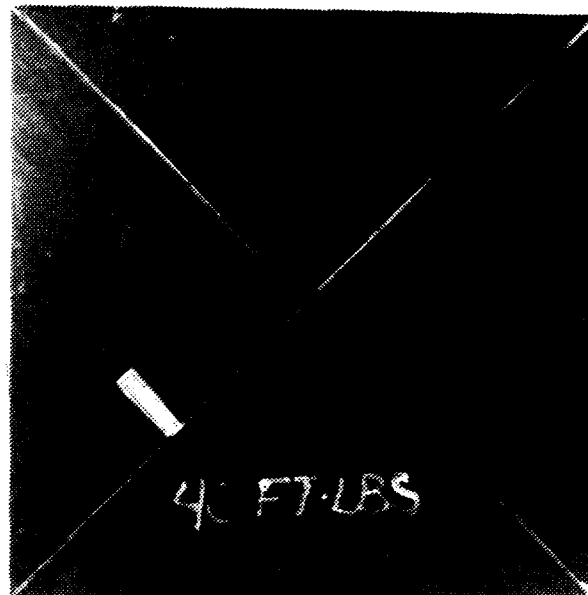
ACL 6422-3 48 PLY (GR/PEEK)  
IMPACT - 40 FT-LBS

**Figure 3-64. Photographs of 48-Ply AS4/APC-2 Gr/PEEK Impacted With a Force of 40 ft-lbs to Achieve Matrix Cracking/Delamination**  
(a), (b) As-Tested Specimen (Top and Bottom Faces)  
(c) Mating Fracture Halves Showing Impact Signature (Arrows)

Figures 3-64 through 3-66 illustrate the three failure modes in Gr/PEEK. A comparison of these results with the data for Gr/Ep shows that the damage zones in Gr/PEEK appear much

smaller; and higher impact loads are required to create the desired failure modes. This is believed to be a consequence of the tougher thermoplastic matrix.

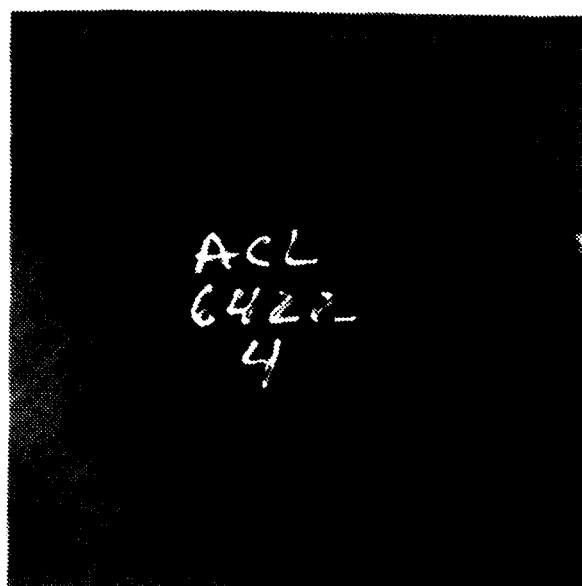
ACL 6422-4 48 PLY (GR/PEEK)  
IMPACT - 60 ft. lbs

**Figure 3-65. Photographs of 48-Ply AS4/APC-2 Gr/PEEK Impacted With a Force of 60 ft-lbs to Achieve Composite Buckling**  
(a), (b) As-Tested Specimen (Top and Bottom Faces)  
(c) Mating Fracture Halves Showing Impact Signature (Arrows)

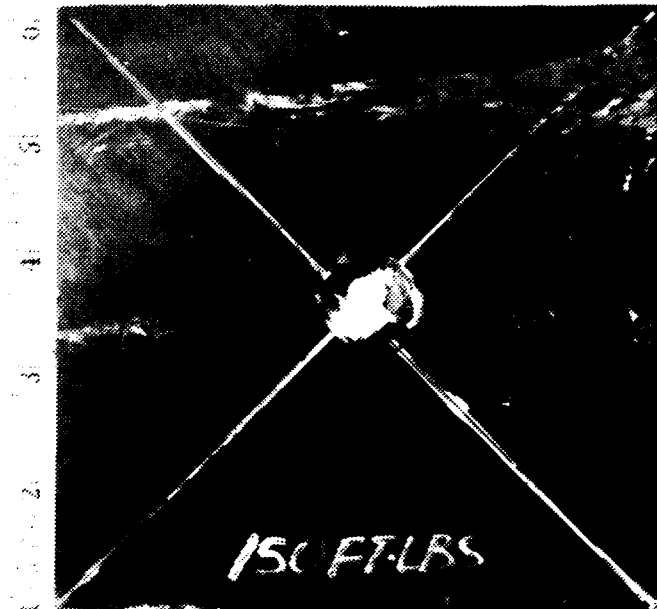
**Figure 3-66. Photographs of 48-Ply AS4/APC-2 Gr/PEEK Impacted With a Force of 150 ft-lbs to Achieve Through-Hole Damage**  
(a), (b) As-Tested Specimen (Top and Bottom Faces)  
(c) Mating Fracture Halves Showing Impact Signature (Arrows)

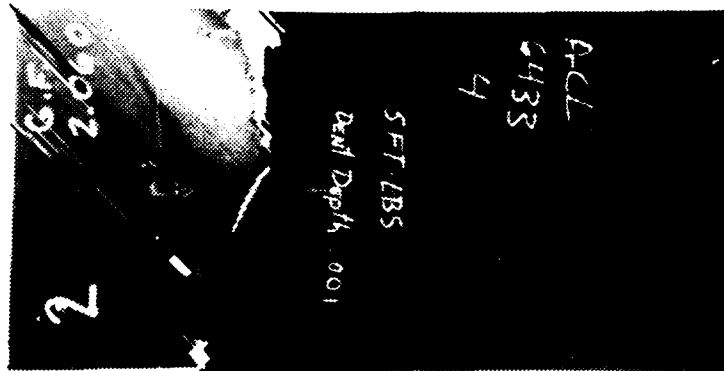
**Figure 3-67. Photographs of 16-Ply AS4/3501-6 Gr/Ep Impacted With a Force of 5 ft-lbs and PIC Tested**  
**(a) As-Tested Specimen**  
**(b) A-Scan of Impact Damage**

Figure 3-67. (Continued)  
(c) Mating Fracture Halves Showing Impact (I) and Compression (C) Failure Regions

Figures 3-67 through 3-70 show photographs of fracture in Gr/Ep and Gr/PEEK that were impact damaged and subsequently PIC tested. Evaluation of the 16-ply Gr/Ep specimen indicated that the compression failure was unrelated to the impact damage (Figure 3-67). It is believed that this was a consequence of the PIC specimen being too thin (16-ply). In the thicker specimens, macroscopic compression failure initiated in the zones of delamination caused by impact (Figures 3-68 through 3-70).

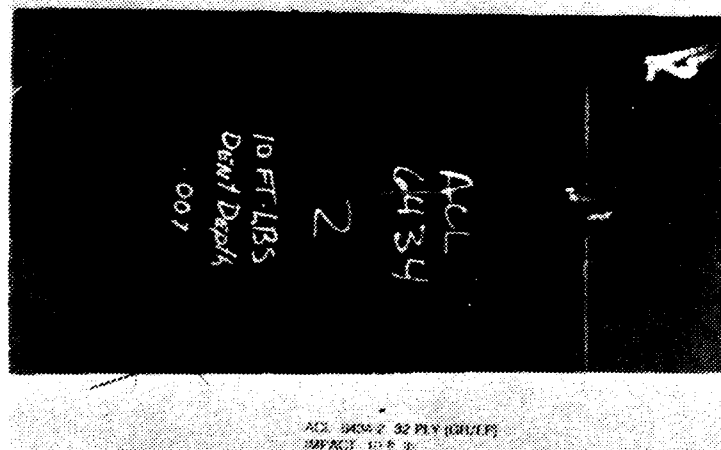
**Figure 3-68. Photographs of 32-Ply AS4/3501-6 Gr/Ep Impacted With a Force of 10 ft-lbs and PIC Tested**  
**(a), (b) As-Tested Specimen (Top and Bottom Faces)**

Figure 3-68. (Continued)  
(c) Mating Fracture Halves Showing Impact (I) and Compression (C) Failure Regions

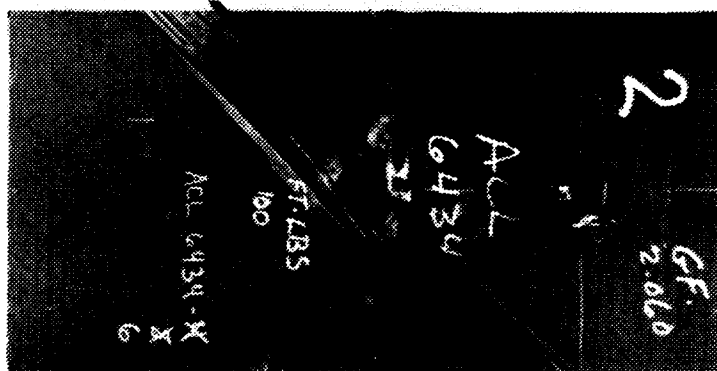
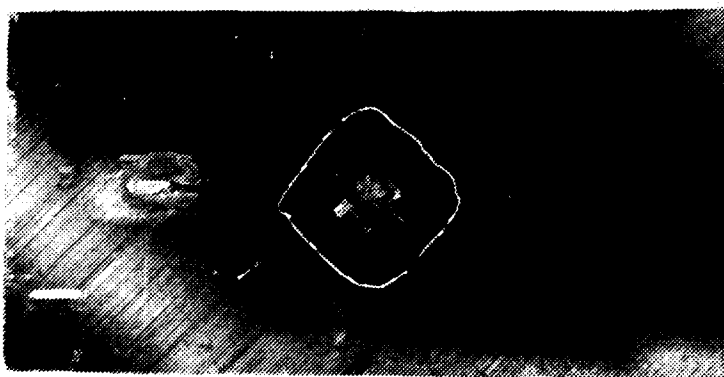
**Figure 3-69. Photographs of 32-Ply AS4/3501-6 Gr/Ep Impacted With a Force of 100 ft-lbs and PIC Tested**  
**(a) As-Tested Specimen**  
**(b) A-Scan Showing Impact Damage**

Figure 3-69. (Continued)  
(c) Mating Fracture Halves Showing Impact (I) and Compression (C) Failure Regions
